## dsPIC33EPXXXGS70X/80X Family Silicon Errata and Data Sheet Clarification

The dsPIC33EPXXXGS70X/80X family devices that you have received conform functionally to the current Device Data Sheet (DS70005258C), except for the anomalies described in this document.

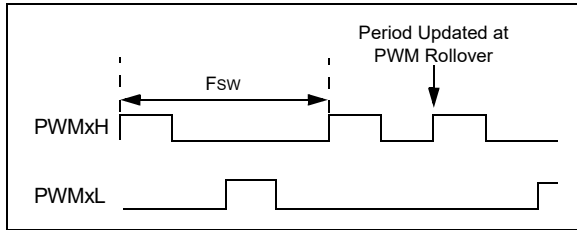
FIGURE 1:

When the PWM module is configured for Push-Pull mode (IOCONx[11:10] = 0b10) with the Enable Immediate Period Update bit enabled (PTCON [10] = 1), a write to the Period register that coincides with the period rollover event may cause the push-pull output logic to produce back-to-back pulses on the PWMx pins (see Figure 1).

Ensure that the update to the PWM Period register occurs away from the PWM rollover event by setting the EIPU bit (PTCON[10] = 1). Use either the PWM Special Event Trigger (SEVTCMP) or the PWM Primary Trigger (TRIGx) to generate a PWM Interrupt Service Routine (ISR) near the start of the PWM cycle. This ISR will ensure that period writes do not occur near the PWM period rollover event.

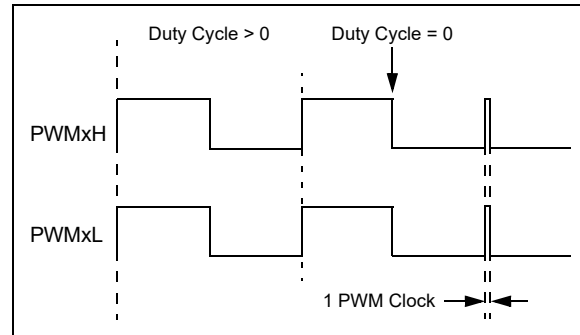
FIGURE 2: EXAMPLE FOR REDUNDANT OUTPUT MODE

In the Redundant Output mode (IOCONx[11:10] = 0b01) and Push-Pull Output mode (IOCONx[11:10] = 0b10), with the Immediate Update Enable bit disabled (PWMCONx[0] = 0), when the Duty Cycle register is updated from a non-zero value to zero, a glitch pulse of a width equal to 1 PWM clock will appear at the next PWM period boundary, as shown in Figure 2 (for the Redundant Output mode). The Duty Cycle register refers to the PDCx register if PWMCONx[8] = 0 or the MDC register if PWMCONx[8] = 1.

If the application requires a zero duty cycle output, there are two possible work around methods:

1. Use the PWM override feature to override the PWM output to a low state instead of writing to the Duty Cycle register. In order to switch back to a non-zero duty cycle output, turn off the PWM override. The override-on and override-off events must be timed close to the PWM period boundary if the IOCONx register has been configured with IOCONx[0] = 0 (i.e., output overrides through the OVRDAT[1:0] bits occur on the next CPU clock boundary).
2. Enable the Immediate Update Enable bit (PWMCONx[0] = 1) while configuring the PWMx module (i.e., before enabling the PWMx module, PTCON[15] = 1). With the Immediate Update enabled, writes to the Duty Cycle register can have an immediate effect on the PWM output. Therefore, the duty cycle write operations must be timed close to the PWM period boundary in order to avoid distortions in the PWM output.

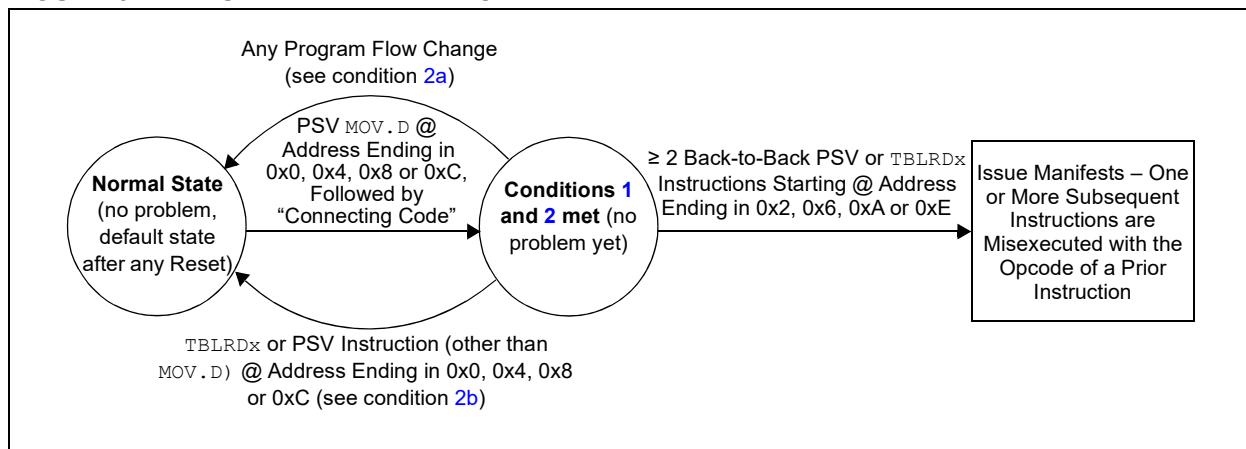
**FIGURE 3: SIMPLIFIED BEHAVIOR**

When two or more data Flash read instructions (via Program Space Visibility (PSV) read or Table Read) are executed back-to-back, one or more subsequent instructions can be misexecuted when all of the conditions in [Table 4](#) occur.

3. $\geq 2$ back-to-back PSV or <code>TBLRDx</code> instructions are executed (following the code of condition 2), where the first of the back-to-back instructions is located at an address ending in 0x2, 0x6, 0xA or 0xE.

[Figure 3](#) provides an example of the effective behavior.

The issue can be avoided by ensuring any one or more of the requirements are not met. For example:

1. All instances of PSV `MOV.D` can be replaced with two PSV `MOV` instructions instead. Non-PSV `MOV.D` instructions acting on RAM/SFRs do not need to be modified; or
2. If not already present, a program flow change instruction (such as `BRA $+2`) can be inserted above back-to-back data Flash read sequences; or
3. Back-to-back data Flash read instruction sequences can be broken up by inserting a non-Flash read instruction (such as a `NOP`), in between the Flash read instructions; or
4. The alignment of the code can be shifted to avoid the required opcode location addresses.

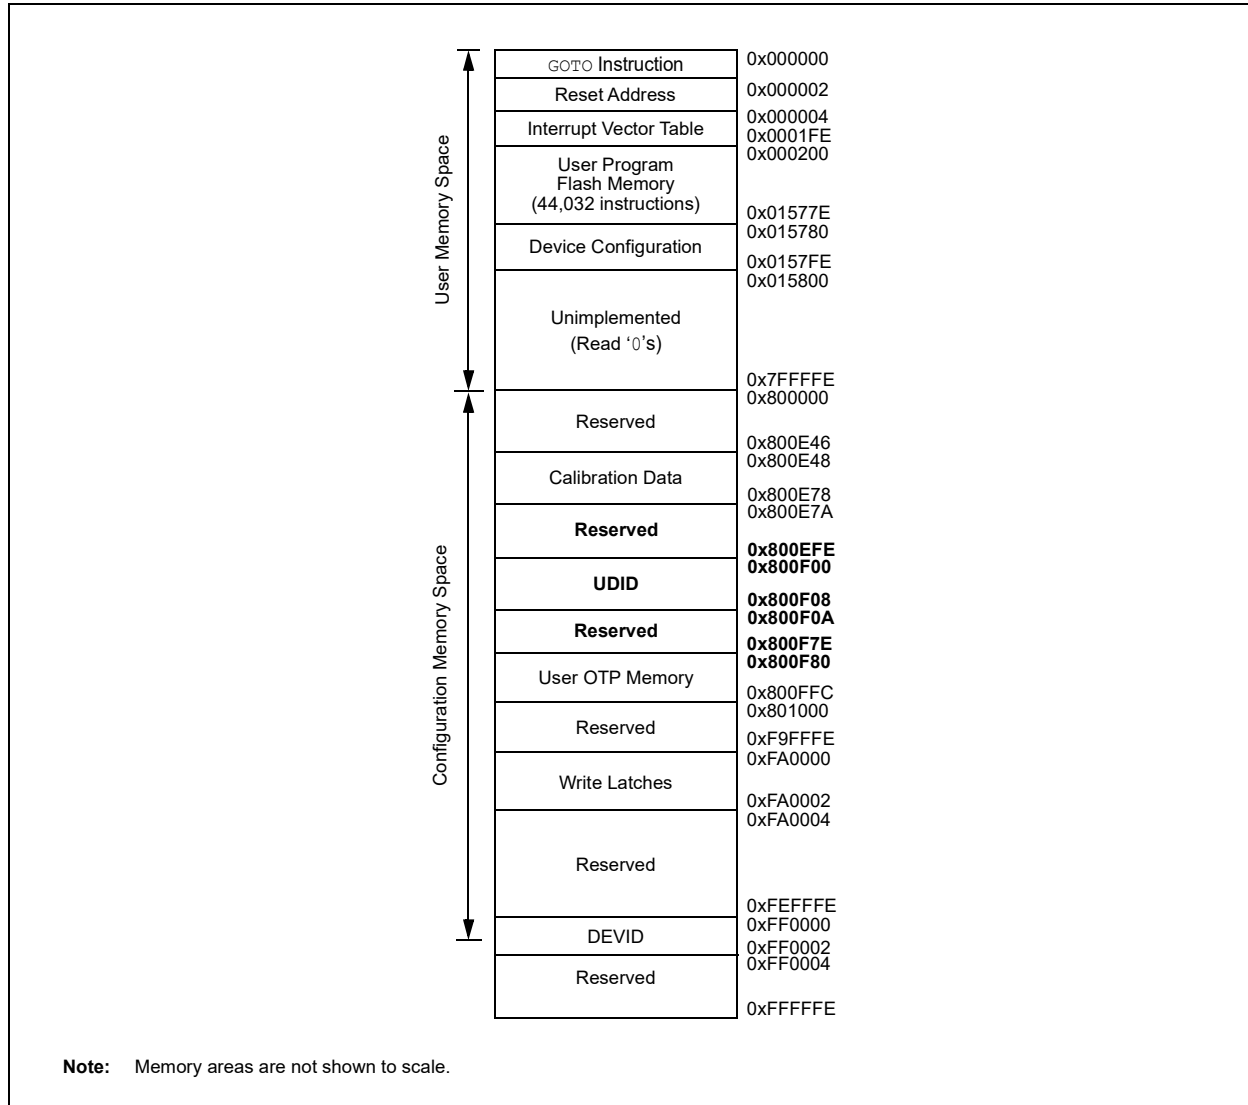
**FIGURE 4-2: PROGRAM MEMORY MAP FOR dsPIC33EP128GS70X/80X DEVICES**

In Figure 4-2, the following changes have been made as shown in **bold**:
